Putting on a New Edge

So that is why we will now show you how a damaged belly edge (from a cello in this example) can be professionally retrofitted. Retrofitting a belly edge is work that should only be placed in the hands of an experienced violin maker.

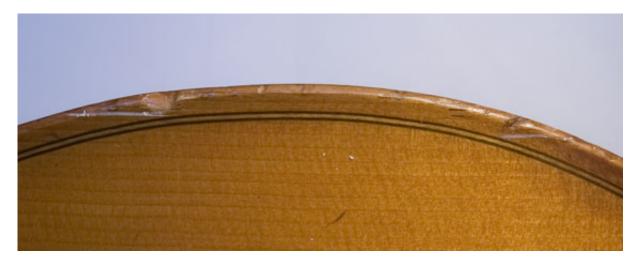
Using our cello example, a Maurice Bourguignon instrument built in 1940, first the belly edge is marked, and this parallel to the respective growth rings during insertion, as described above.

The serious damage above to the left is clear to see, as well as the damage seen in the right of the photo.

The white markings represent the two incisions to which point the belly edge will be removed.
