Putting on a New Edge

So that is why we will now show you how a damaged belly edge (from a cello in this example) can be professionally retrofitted. Retrofitting a belly edge is work that should only be placed in the hands of an experienced violin maker.

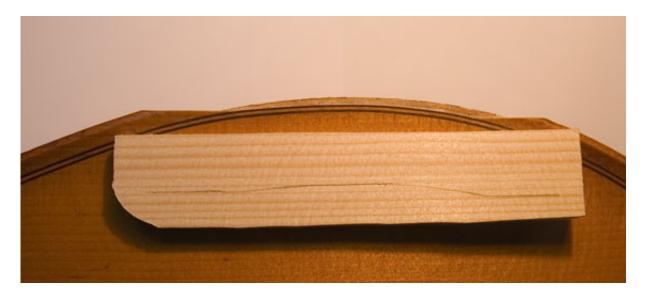
In order to adjust the wood, the peeling off of the belly edge must first take place.

The selected wood should have the structure, grain, growth rings and symmetry that come closest to the original. The violin builder normally has a treasure chest of aged woods at his disposal so that the appropriate wood can be found for every type of older instrument. Being that our workshop has been in existence since 1932, you can imagine that we have a wonderful selection of repair woods of all variations at our disposal.

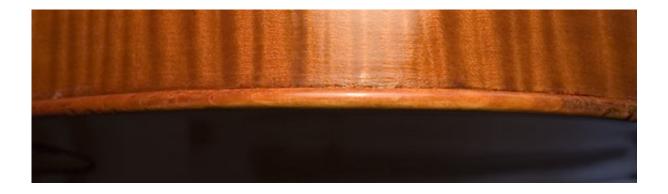
Now it the ribside fits again:
